**Structural hydrology and
limiting summer conditions of
San Juan County fish-bearing streams**

June 2010

Structural hydrology and limiting summer conditions of San Juan County fish-bearing streams

Russel Barsh – Kwiáht

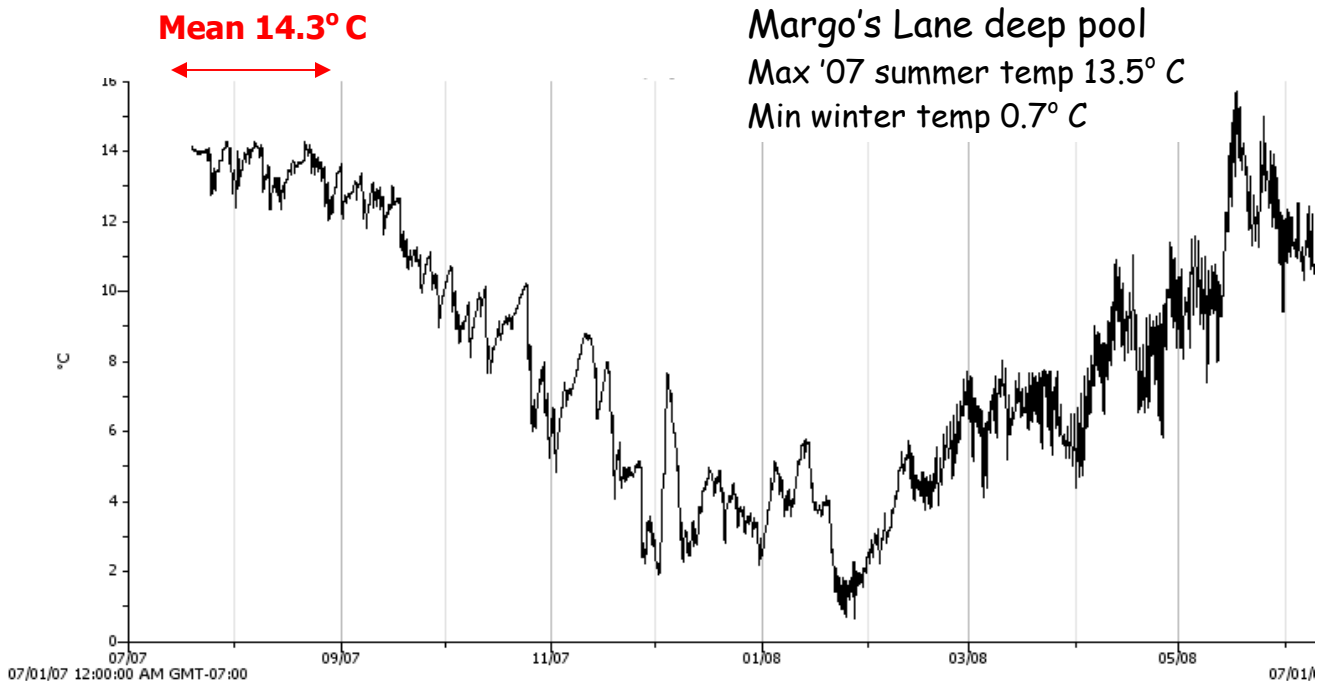
Appendix II.2

Crow Valley Pool Temperatures

Summer 2007 - Spring 2008

Temperature fluctuations were measured hourly in pools in five streams where we found cutthroat or sticklebacks (Appendix II). Diurnal and seasonal variation was greater at Cascade, Crow Valley and West Beach than at either Garrison or Doe Bay, but with no obvious consequences for fish survival. Average summer temperatures were well within the reported comfort range for cutthroat in 2008-2009, but it should be borne in mind that summer weather can vary considerably from year to year. An unusually warm summer—or the removal of shading vegetation—could easily raise stream pool temperatures from a comfortable 14-16°C to a potentially dangerous 20°C or greater.

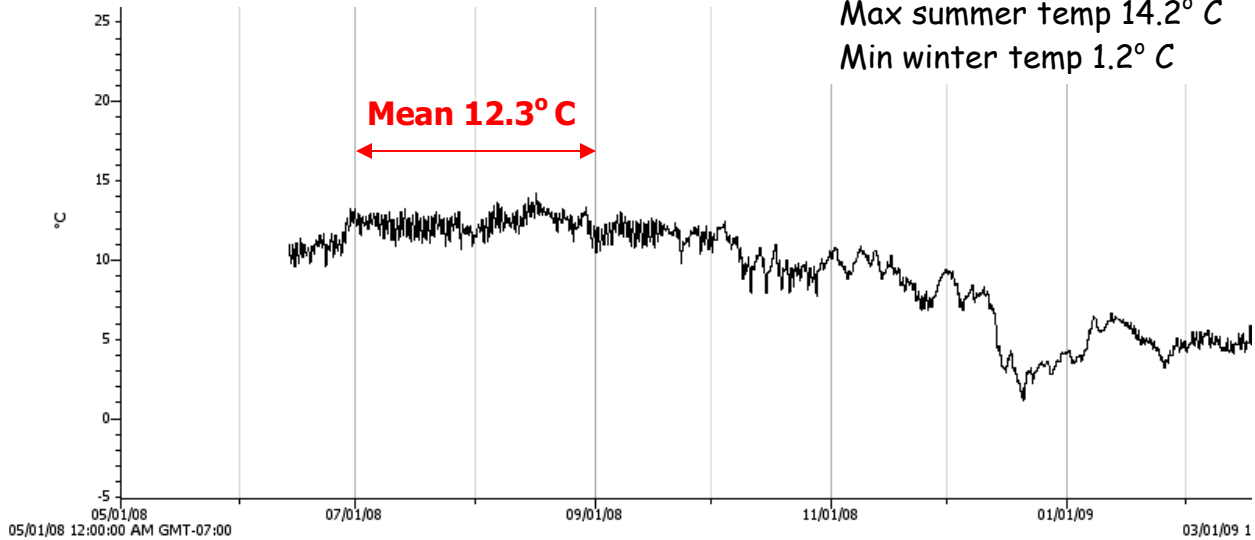
Max summer temp 14.2° C

Min winter temp 1.2° C

Garrison Creek Pool Temperatures

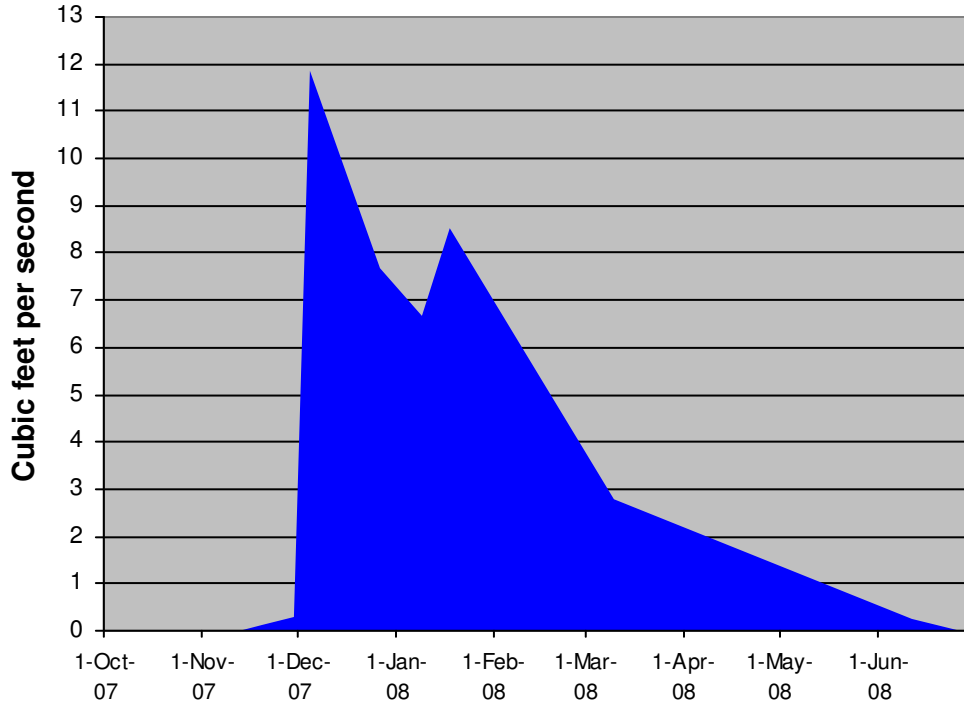
Appendix III.3

**Hydrograph of Crow Valley Creek
Measured at Margo's Lane, winter 2007-2008**

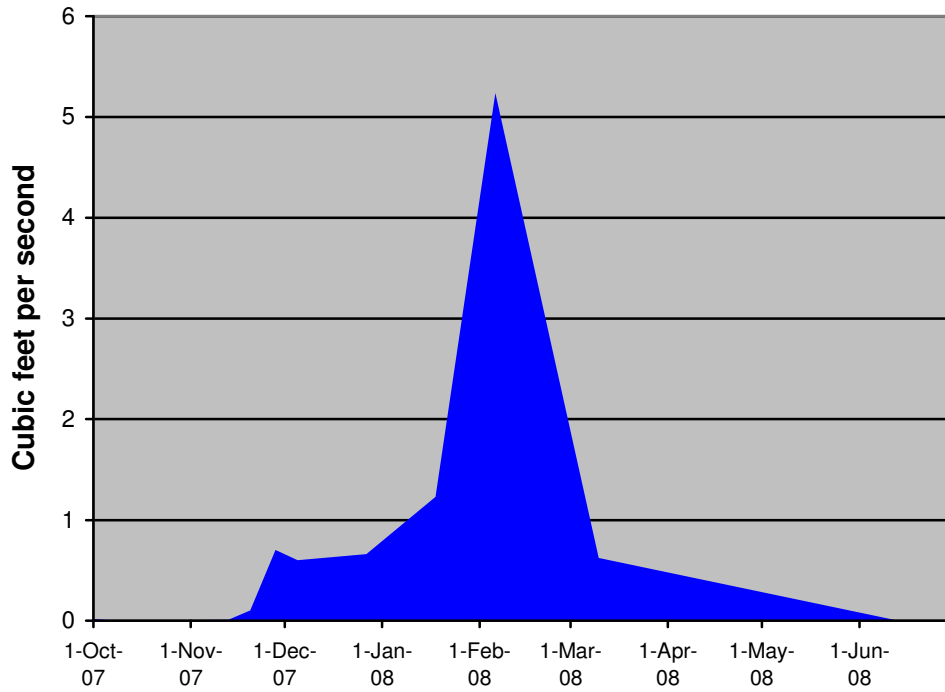
Appendix III.5

**Hydrograph of Pickett Spring Creek
Measured at Johnston's Pond outlet, winter 2007-2008**

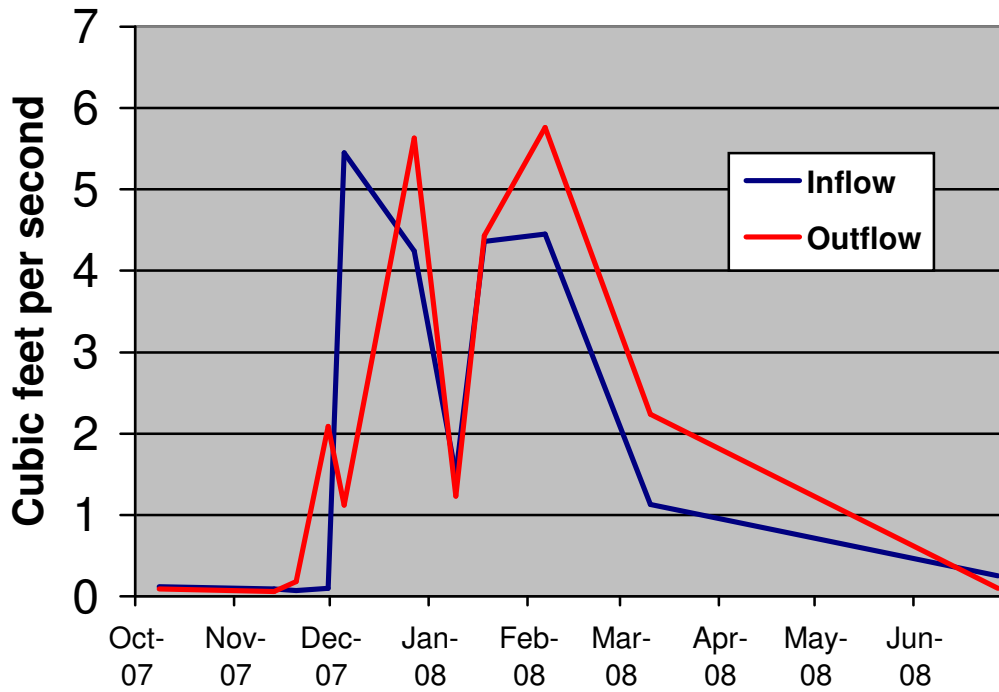
Appendix III.8

Comparison of Pottery Pond inflows and outflows

Measured at West Valley Road and at beach

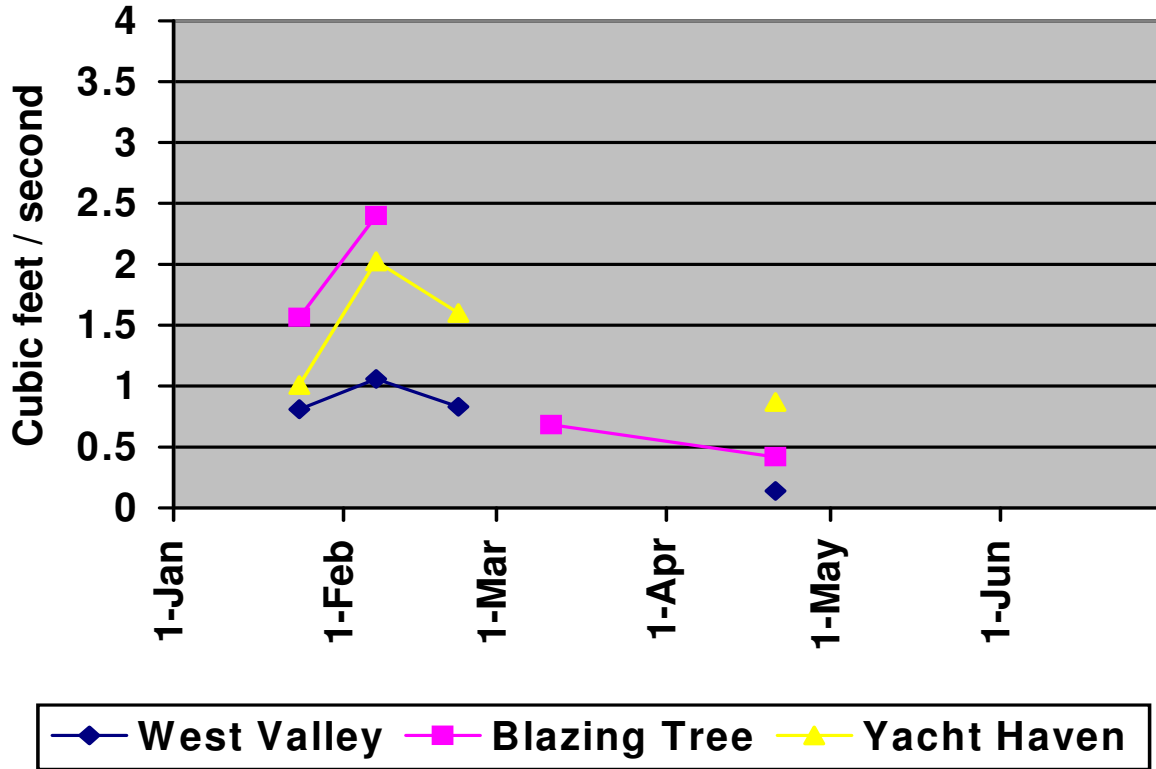
Appendix III.8

Hydrograph of Garrison stream at West Valley Road
(Winter 200)

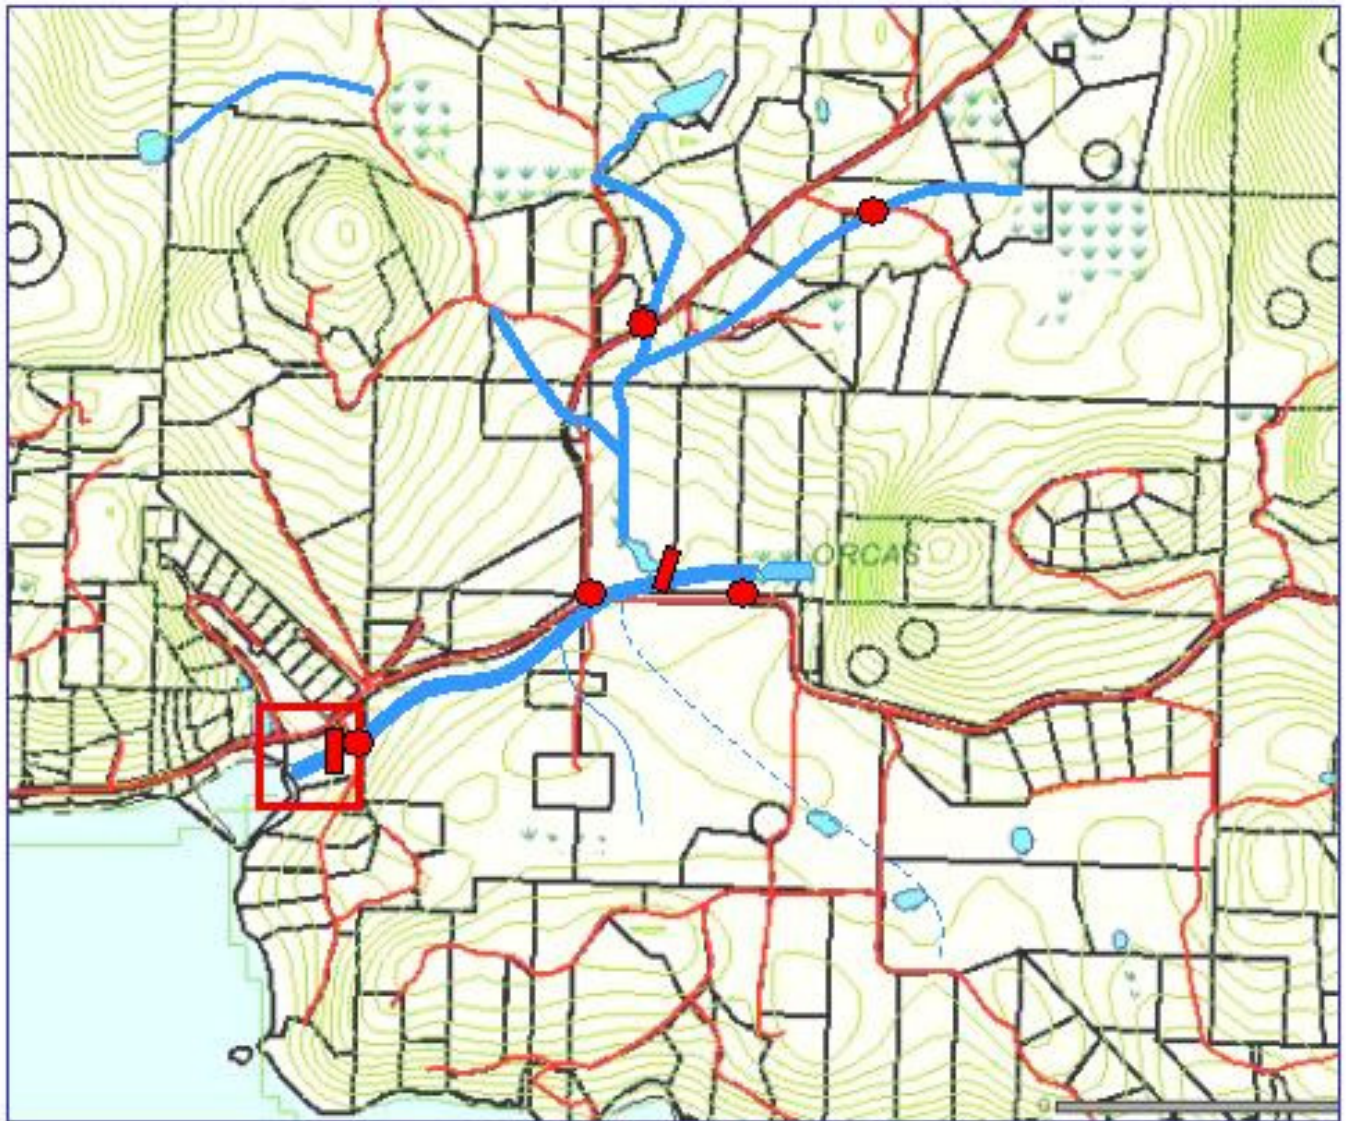
Appendix IV.2
Bayhead-Victorian, Orcas
Structural diagram

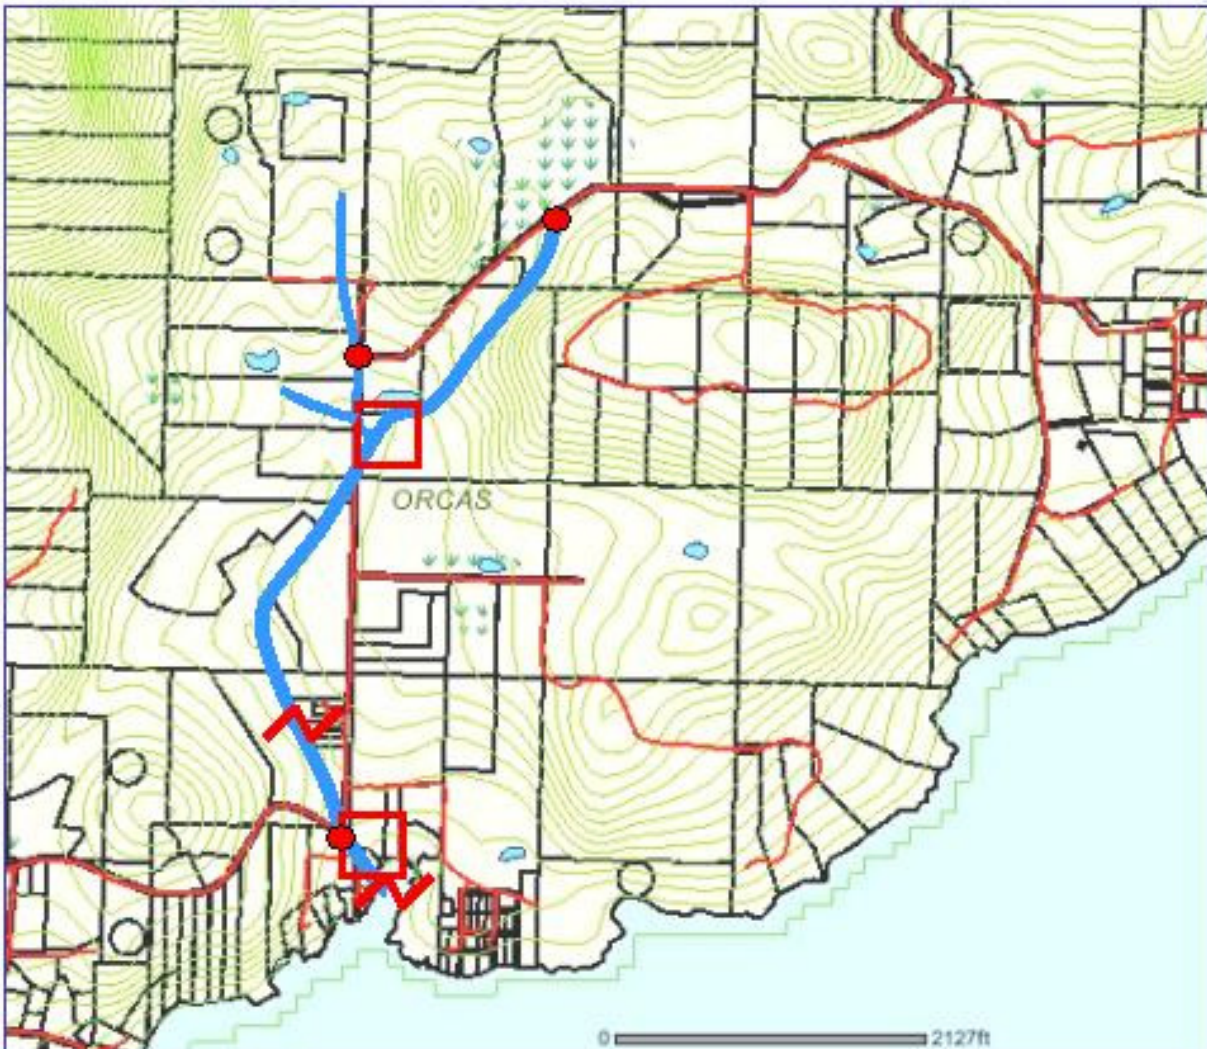
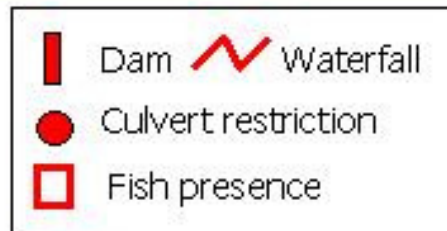
Appendix IV.5
Doe Bay, Orcas
Structural diagram

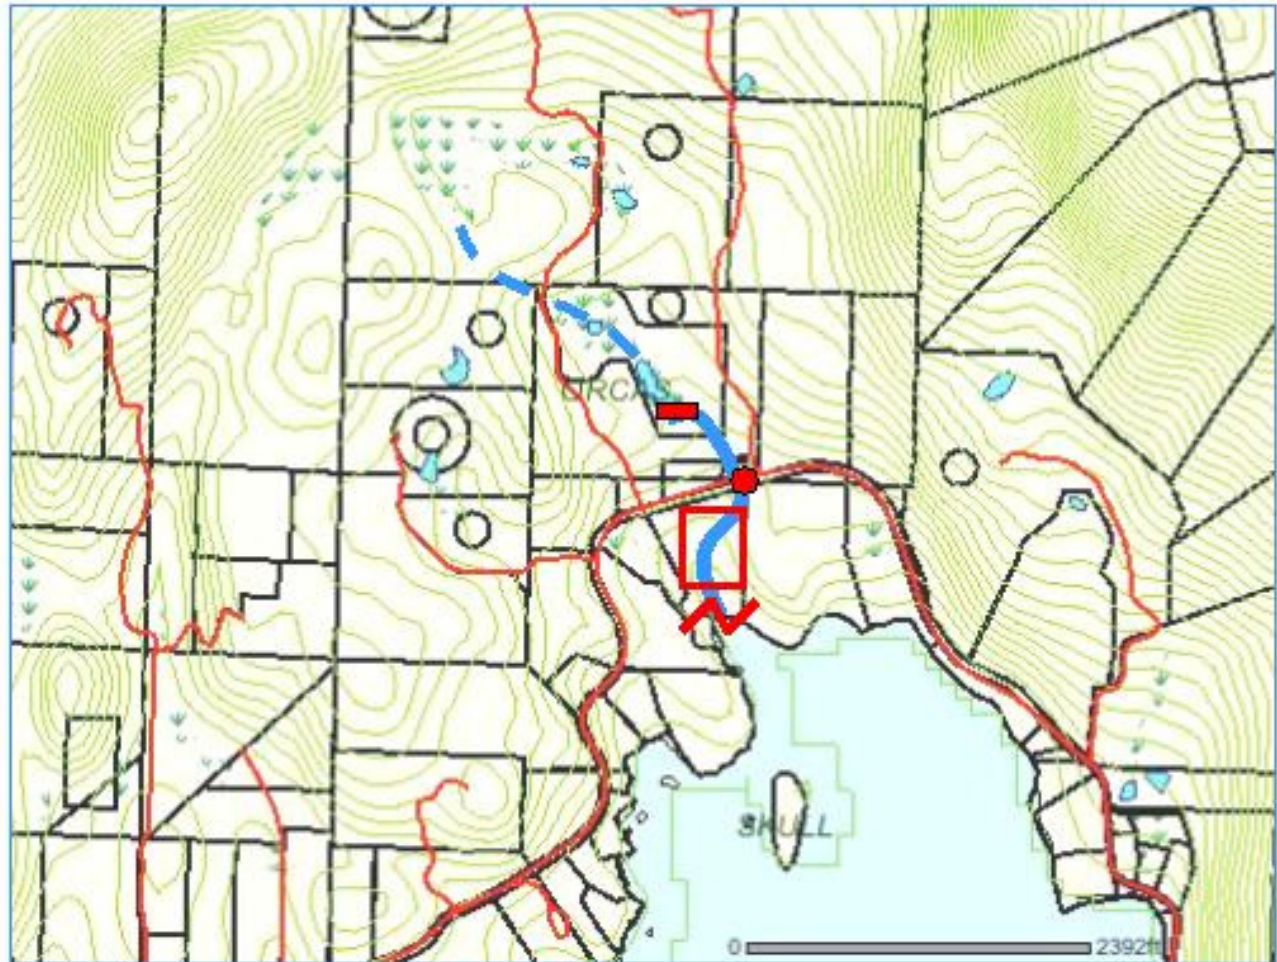
Appendix IV.6
Skull Creek, Orcas
Structural diagram

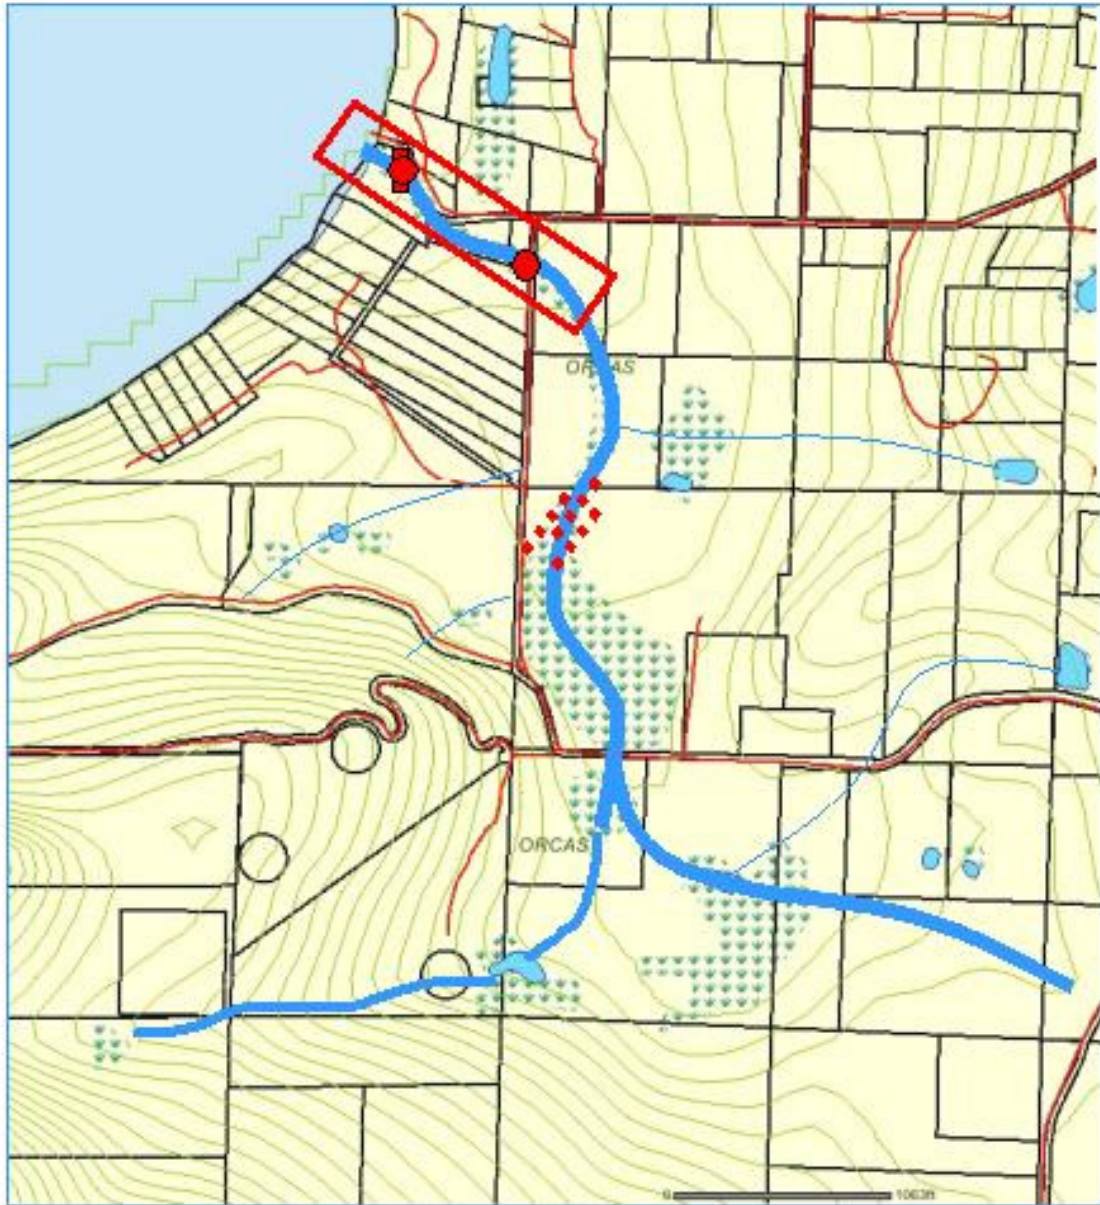
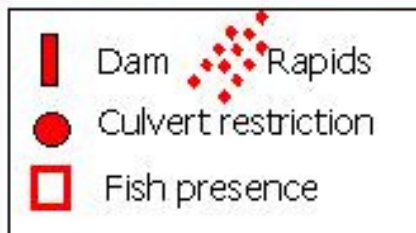
Appendix IV.7

West Beach, Orcas

Structural diagram

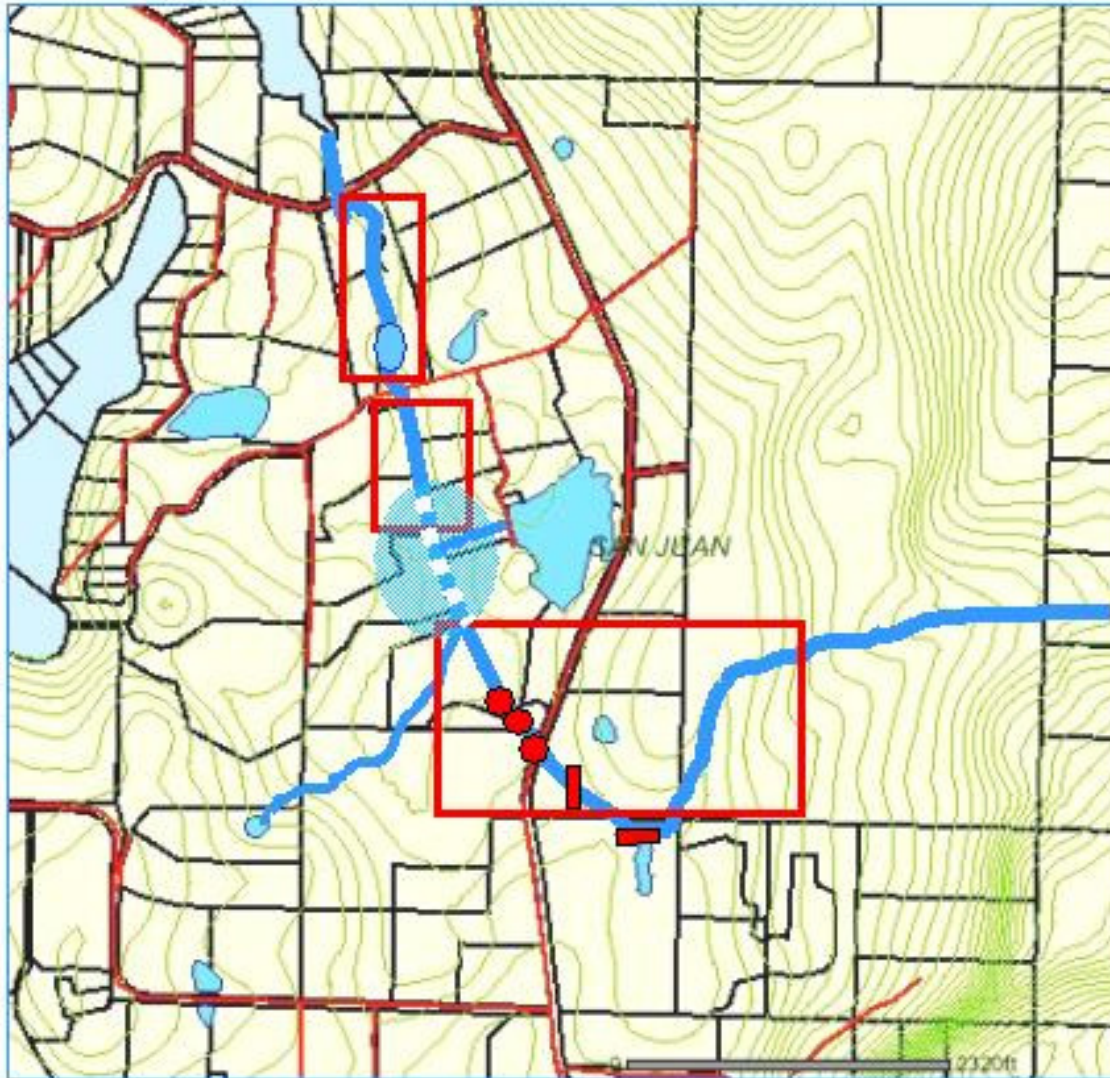
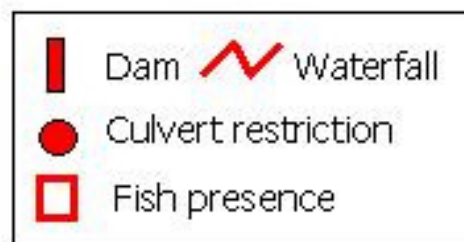
Appendix IV.8
Garrison, San Juan
Structural diagram
