**Structural hydrology and  
limiting summer conditions of  
San Juan County fish-bearing streams**

June 2010

**KWIÀHT**

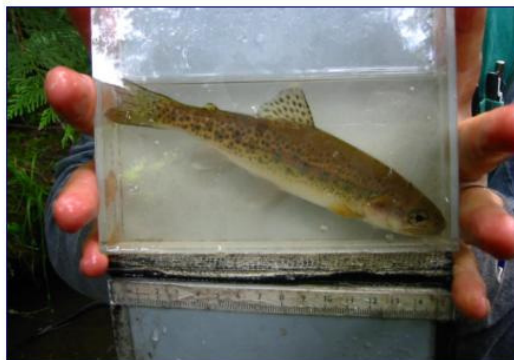
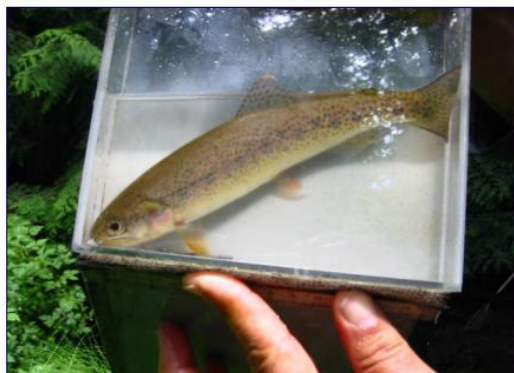
Cutthroat trout (likely sea-run) from Bayhead in 2004: a run lost in 2007 due to impoundment of flows by ponds.

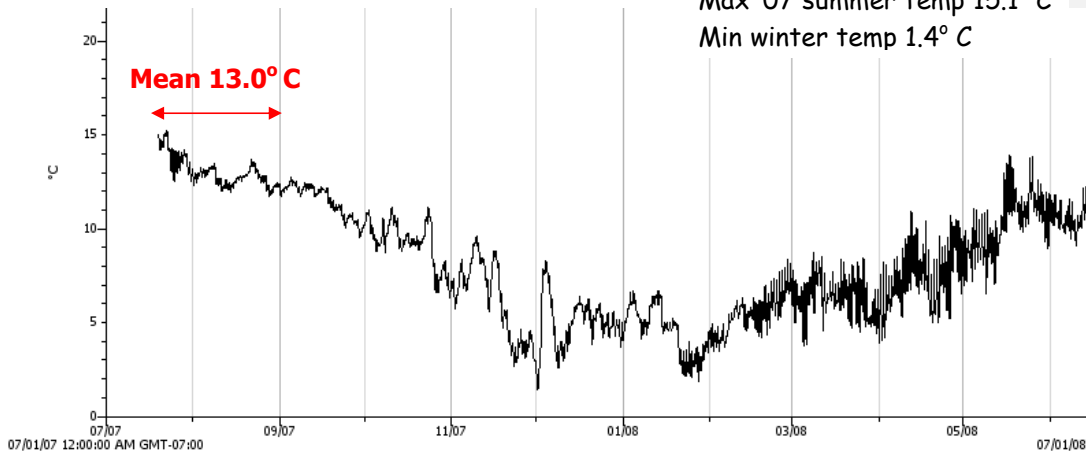
Appendix II.3

## Doe Bay Pool Temperatures Summer 2007 - Spring 2008

County road plunge pool  
Max '07 summer temp 15.1° C  
Min winter temp 1.4° C

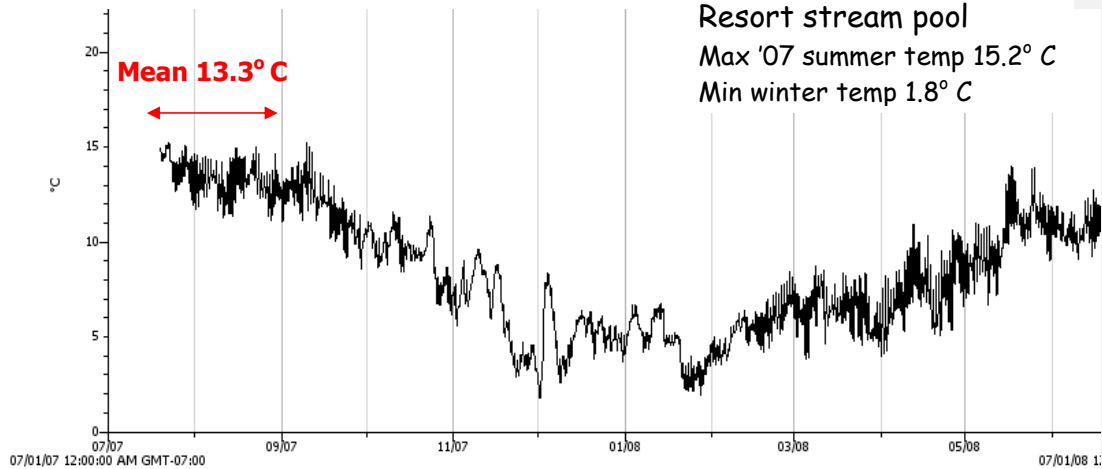
Resort stream pool  
Max '07 summer temp 15.2° C  
Min winter temp 1.8° C

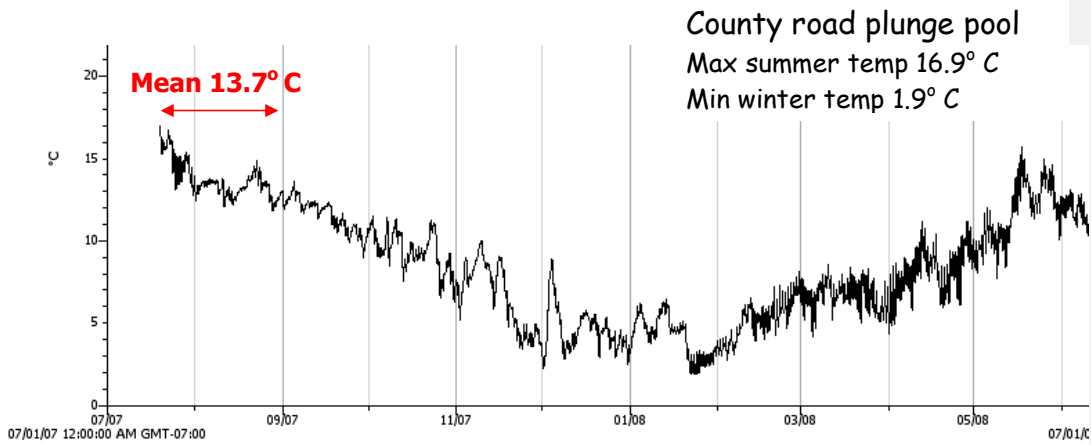
Appendix II.4

## West Beach (Bonnie Brook) Pool Temperatures Summer 2007 - Spring 2008

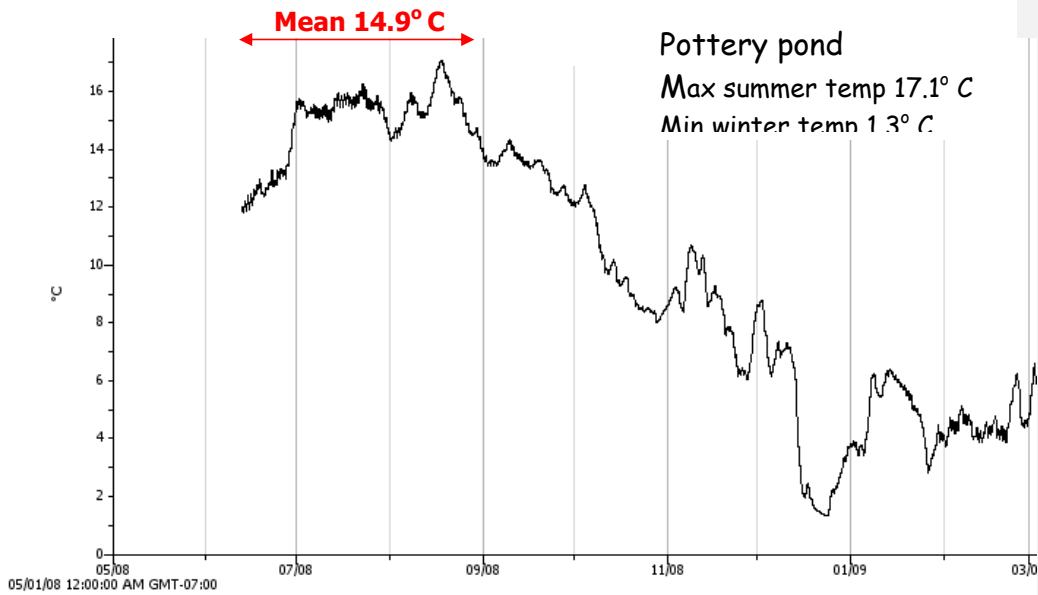
Appendix II.5

### West Beach (Bonnie Brook) Pool Temperatures Summer 2008 - Winter 2009

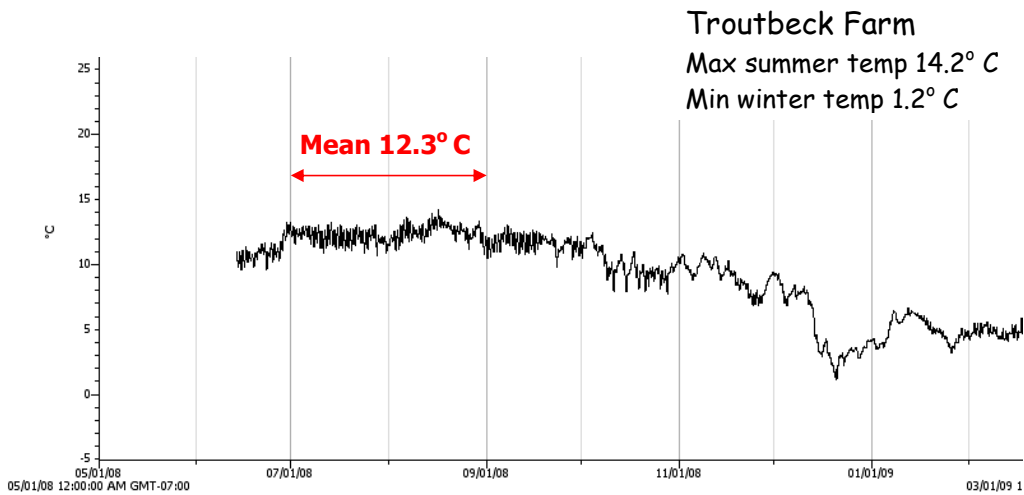
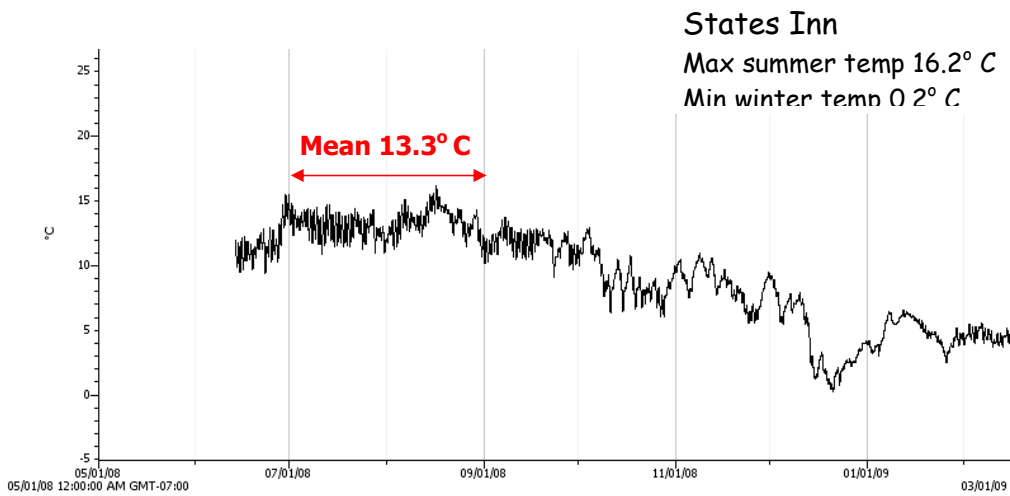
Appendix II.6

## Garrison Creek Pool Temperatures Summer 2008 - Winter 2009

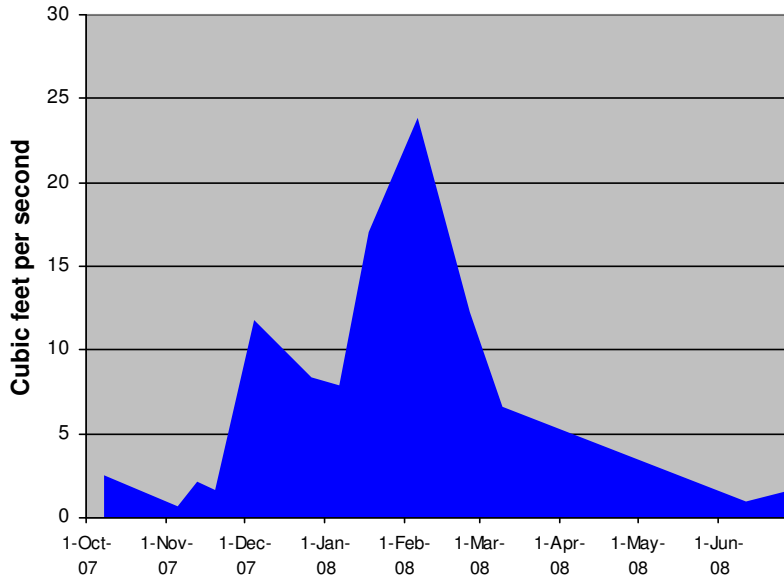
### Appendix III.2

**Hydrograph of Cascade Creek**  
Measured at Pt. Lawrence Road, winter 2007-2008

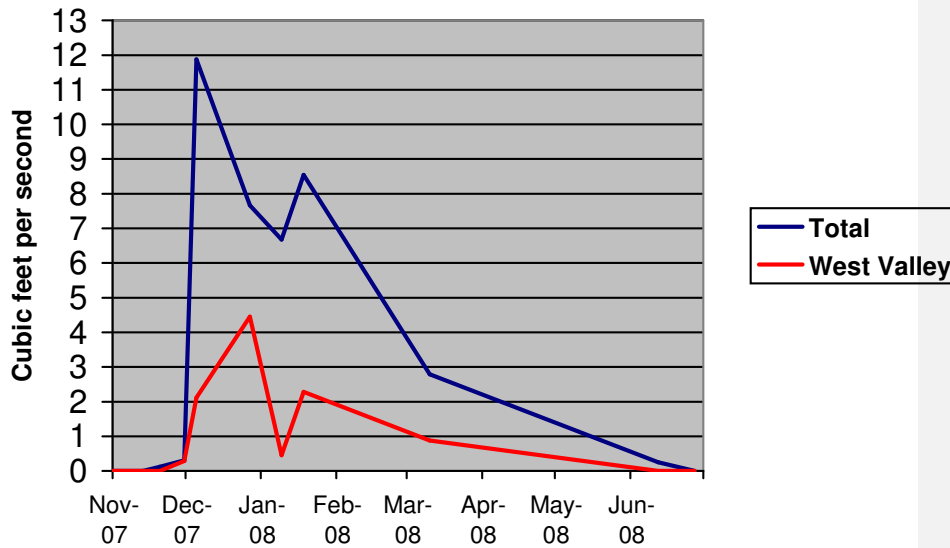
**Contribution of west valley wetlands to  
stream flows measured at Obstruction Pass Road**

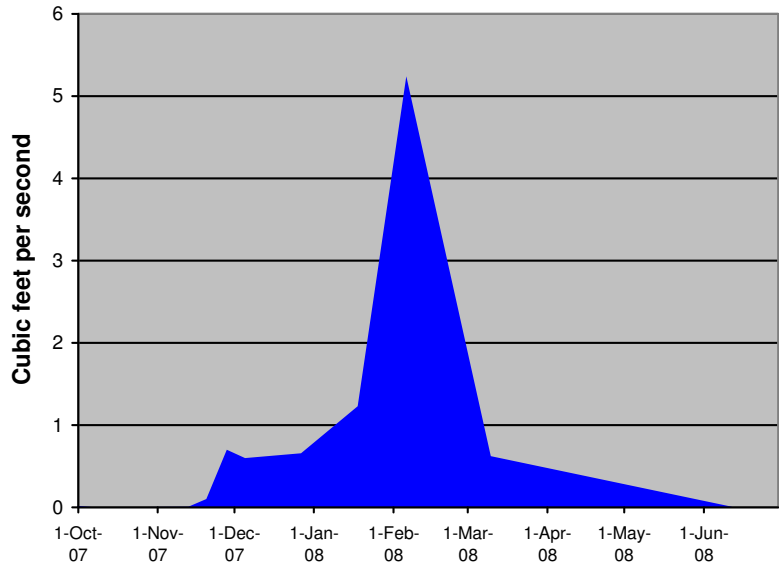
### Appendix III.5

**Hydrograph of Pickett Spring Creek  
Measured at Johnston's Pond outlet, winter 2007-2008**

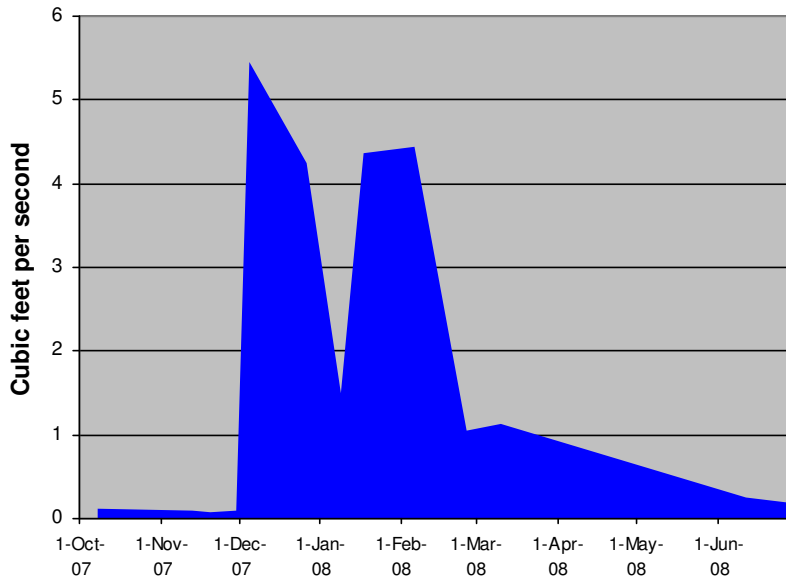
### Appendix III.6

**Hydrograph of the West Beach (Bonnie Brook) stream**  
Measured at West Beach Road culvert, winter 2007-2008

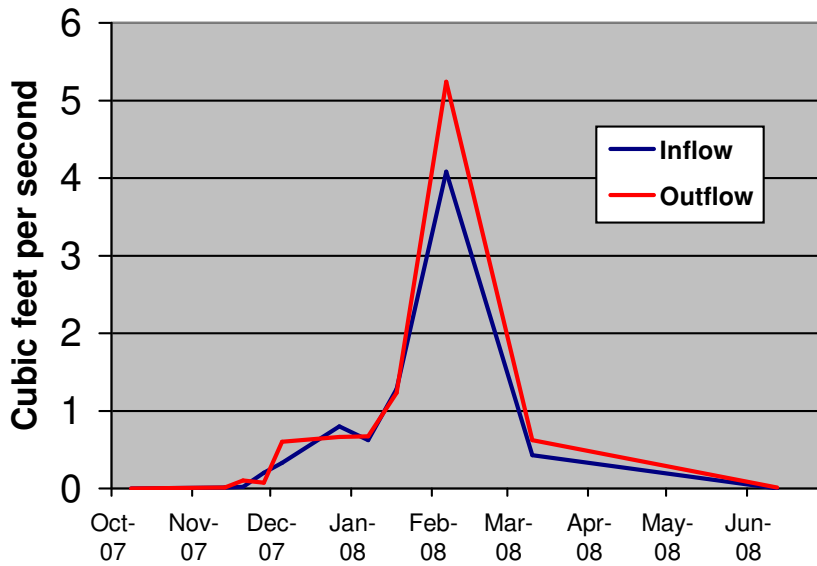
**Comparison of Johnston-Eisner ponds inflows and outflows**  
Measured at Obstruction Pass Road and Johnston's Pond outlet

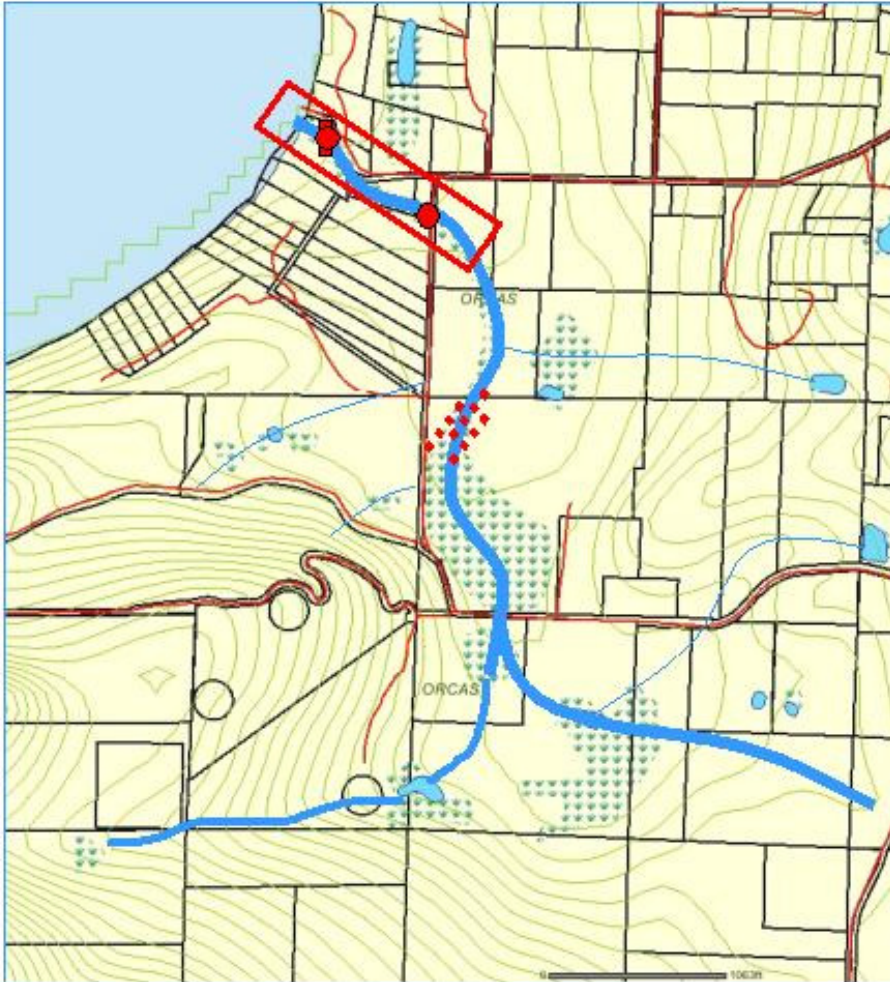
Appendix IV.7  
West Beach, Orcas  
Structural diagram

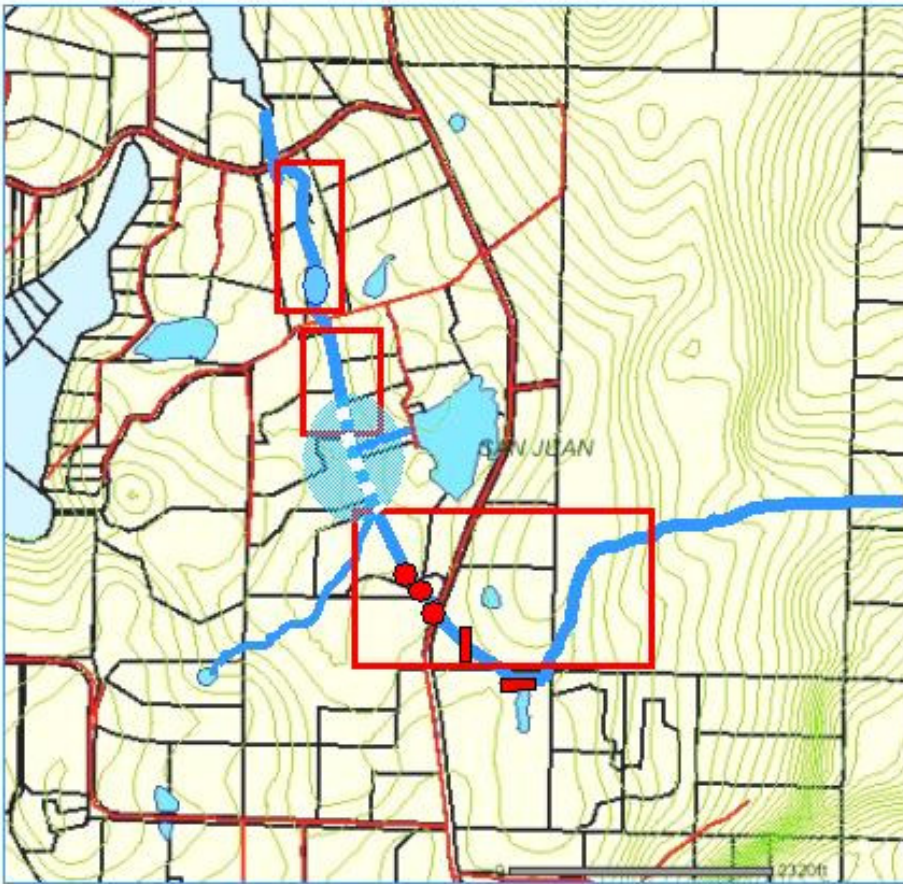
Appendix IV.8  
**Garrison, San Juan**  
Structural diagram
